Inspection Report Minerals Regulatory Program

Mine Name: - Kingston Canyon Rock

Inspection Date: June 13, 2012

Inspection Purpose: Evaluate earthwork reclamation for partial release

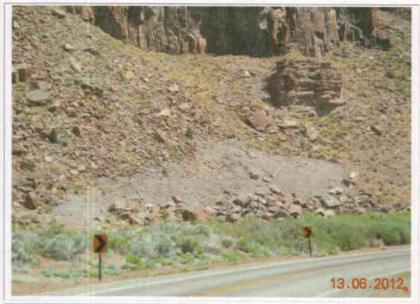
West disturbance: Recently recontoured with vegetation beginning to grow.

It is recommended that the reclamation earthwork be approved. The Division will continue to inspect the site to evaluate revegetation success.

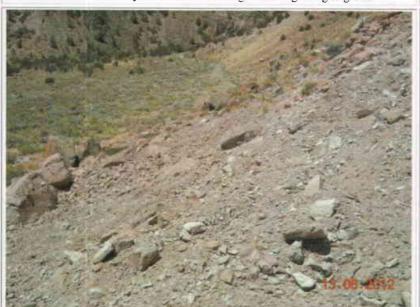
The older excavation appears stable, and is vegetated with cheatgrass. Fines and soil are present despite the area's rockiness. Some erosion is possible on the recently-recontoured west area until vegetation establishes, but it is not anticipated to be a problem. Access roads were graded and roughened in 2012. Stan Beckstrom has indicated that seeding occurred in October 2012. Weeds (possibly gumweed) with some new or returning beneficial grasses and penstemons were starting to grow on roads. Photos were taken to document site conditions.

East disturbance: Recontoured previously; cheatgrass is the dominant vegetation.
